Lessons from Grenfell Tower accident

A. Munjiza, M. Batinić, A. Mihanović

The Grenfell Tower, a building in which public flats in West London, had been hit by a fire on June 14, 2017, in which 71 people were killed and more than 70 were injured, the fire was extinguished only after 60 hours of intense shutdown

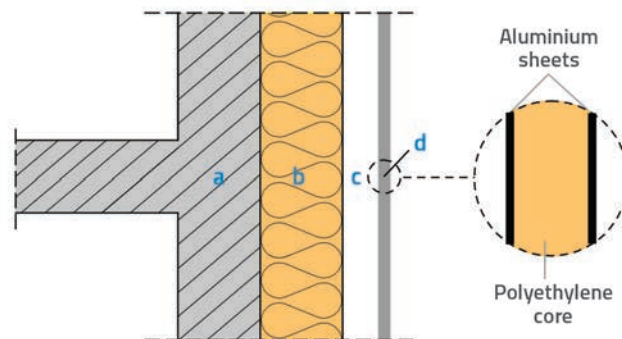
Figure 2. Exterior cladding installed in 2016: a) existing reinforced concrete structure, b) Celotex FR5000 insulation material – 150 mm, c) 50 mm air gap, d) Cladding – 3 mm

It could be argued that the organic cladding material, although insignificant in terms

of volume and energy content, was able to produce flammable gas when heated. This gas penetrated the 5cm continuous cavity enveloping the entire building. Inside the cavity, a relatively small amount of flammable gas mixed with air created a flammable mixture. Once ignited, the entire cavity was on fire in a matter of seconds. Thus, the cladding did not jeopardise the fire safety of the building in terms of design norms, but it acted as an ignition mechanism, facilitating the spreading of fire. This process is rather new, and has not been anticipated by any design codes either in the USA, Japan, EU or the UK. The disaster could have been prevented only if either real or virtual experiments had been conducted, which could have indicated the presence of a trigger like mechanism for a catastrophic and rapid fire propagation. It could also be argued that a similar situation, albeit of a different nature, occurred in the case of Twin Towers, which were in fact designed to survive an impact of an aircraft. However, no one envisioned that this impact would create a trigger like mechanism resulting in structural weaknesses and progressive collapse. It was not the energy of the impacting aircraft that destroyed the towers – it was the potential energy of the towers themselves that destabilised the towers, thus causing a progressive collapse. The impact of an aircraft was just a starting mechanism for the progressive collapse process. The design codes available at that time failed to address this potential hazard.

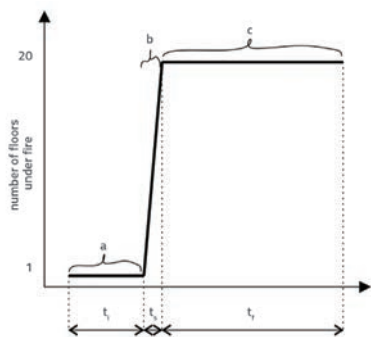
affected by the cladding: in fact, this is implicitly acknowledged by the fact that the cladding has been widely used in the construction industry. However, if fire propagation as a function of time is studied more closely, Figure 3, it can only be concluded that the fire spread from the 4th floor to the rest of the building in a sudden burst.

Figure 3. Fire extent as a function of time

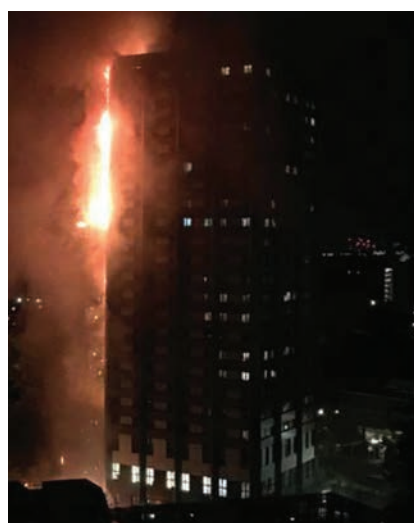
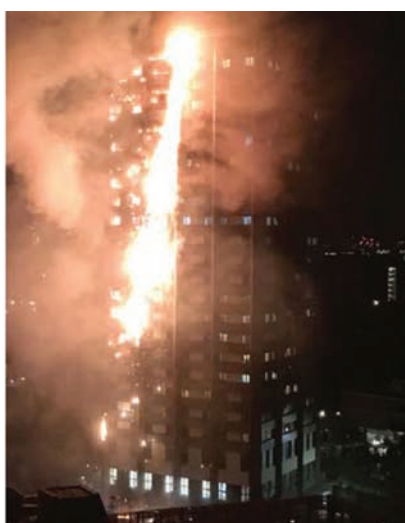
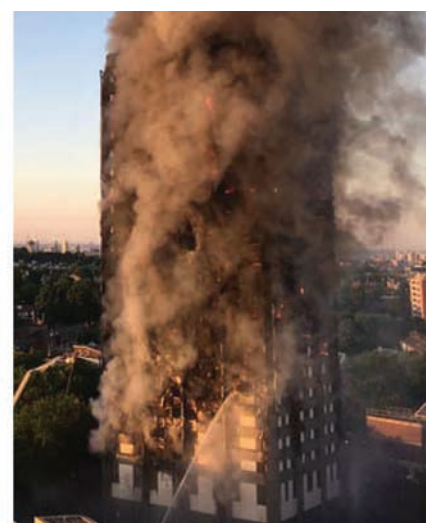
In Figure 4, the extent of fire as a function of time is shown in terms of real photographs. The initial stage of fire propagation, t_1 , is relatively long and is limited to the 4th floor. The final stage of fire, t_3 , is even longer and it involves simultaneous fire on all twenty floors. The transition from initial to final stage occurred extremely fast, with the transition time, t_2 , lasting less than few minutes, and the most violent part of the transition literally lasted few seconds only.

Figure 4. Visual and graphic representation of fire extent as a function of time
