Comprehensive Reconstruction of the *Hrvatski dom* Building in Petrinja

Professional paper

After the 2020 earthquake, the building of the Croatian Home in Petrinja was damaged, and a comprehensive reconstruction was carried out. This paper presents the entire restoration process - from the initial inspection and investigation works, through design development and selection of the strengthening concept, to the implementation of works within the framework of the structural strengthening supervision. The reconstruction of the Croatian Home building represents an example of a successfully completed comprehensive restoration and contributes to the revitalization of life in Petrinja, as the building holds particular importance for the city's cultural life.

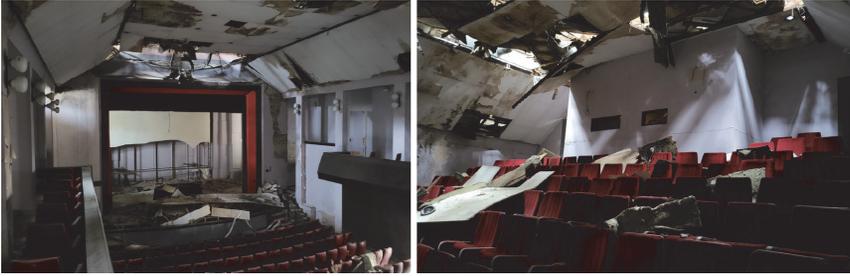
Figure 4. Condition of the great hall at the commencement of project implementation [3]

At the commencement of the project assignment in 2022, the building was not in operation due to the condition resulting from the earthquake. Certain load-bearing and non-load-bearing elements have completely lost their structural stability, rendering the building unfit for use.

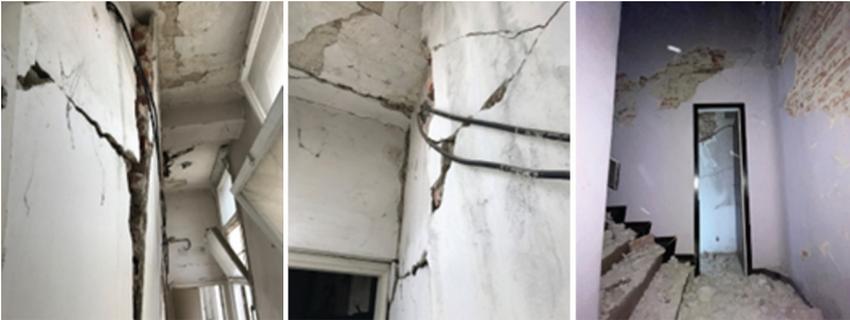
Figure 5. Condition of load-bearing and non-load-bearing walls resulting from loss of out-of-plane stability [3]

The basement floor remains in relatively good structural condition; however, significant damage to both structural and non-structural components is present at the ground floor and first-floor levels, where a risk of local or progressive collapse has been identified. The great hall represents the most critical structural zone of the building due to the extent of damage sustained. In addition, partial failure of the roof structure following the earthquake allowed the ingress of atmospheric agents, leading to pronounced deterioration of both structural and non-structural elements. Moisture exposure and water infiltration have saturated the elements of the hall, resulting in uncontrolled structural failures within the hall space. Owing to the absence of protective measures, the resulting deterioration is progressive and accelerates the spread of damage throughout the remainder of the building.

In order to prevent damage to the partition walls and drastically limit displacements, the ceiling structures will be attached to both the outer and interior walls. The loss of stability of the walls out of plane, which has recently been an issue in some places, will be prevented by keeping the walls at the levels of the ceiling diaphragms.

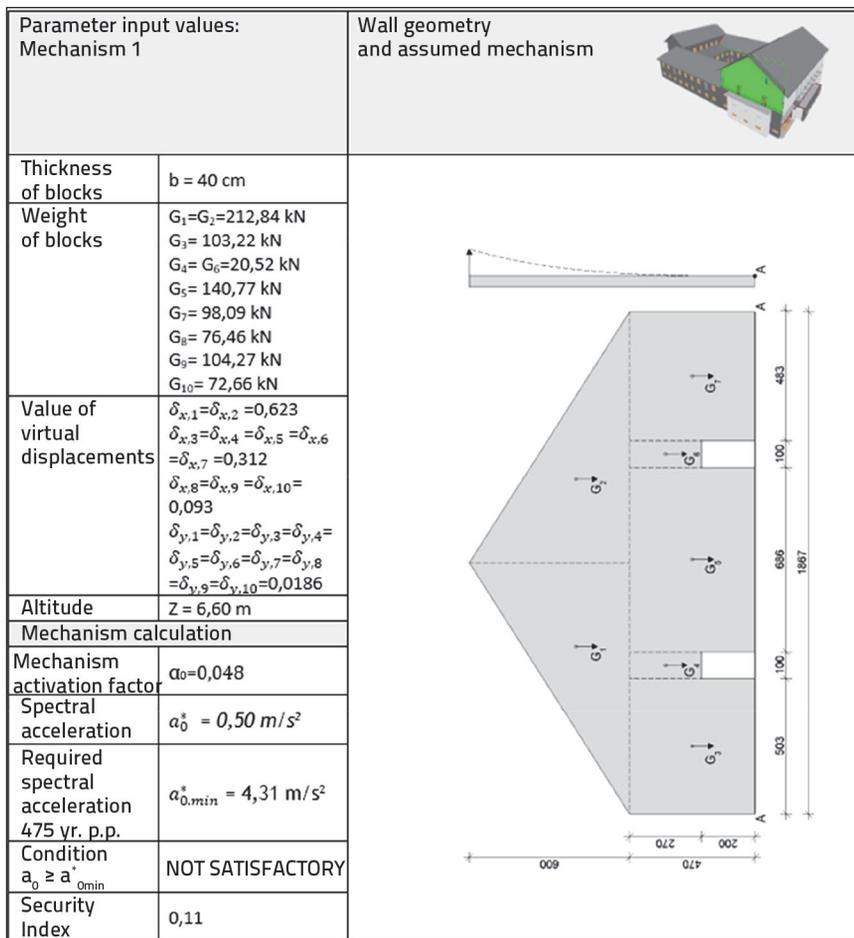
Local calculations performed for several local wall failure mechanisms showed that they do not satisfy the safety check for a return period of 475 years. The calculation of selected walls that are not laterally restrained within their

Figure 21. Calculation of the out-of-plane wall failure mechanism [11]

span has shown that they can be activated at a peak ground acceleration of 0.152 g. Furthermore, the wall damage that occurred after the earthquake indicates partial separation and out-of-plane failure of the observed walls. Mechanism O1, a dovetail mechanism with the gable wall, satisfied 11 % of the demand, while Mechanism O2, the unrestrained facade wall, satisfied 85 % of the demand based on linear analysis. It is important to emphasize that the verification of out-of-plane failure is primarily necessary because the analysis of the global model is valid only under the assumption that the structure responds as an integral whole.

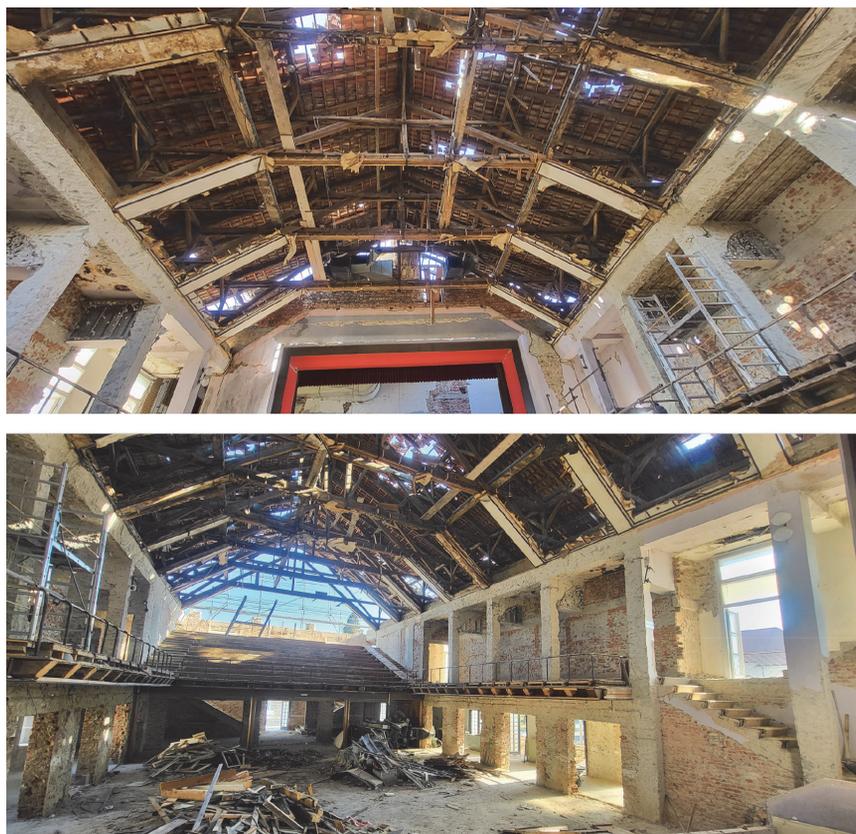
Figure 39. Images of the phase after removal of the cladding, when the structure is fully exposed [3]

The initial construction period is the most intensive and requires the greatest commitment for the structural designer. The reason for this is the necessity of analyzing the existing condition of the load-bearing structure after removing all cladding. The structure's dimensions, layout, and any damage are all clearly obvious at this point.

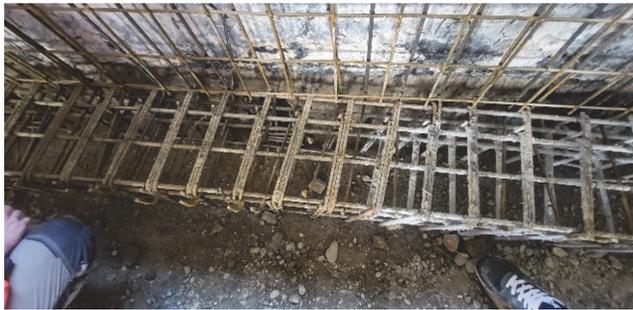
Figure 41. The current state of the existing structure of the large hall after the removal of the wooden roof [3]

In this particular instance, it was both necessary and justified to remove the severely damaged portions of the structure (the large hall's roof) in order to replace them with reinforcements that would guarantee the earthquake resistance of the exact portion of the structure that had the initial flaws.

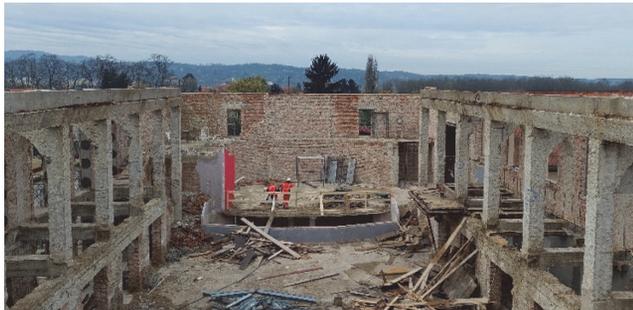
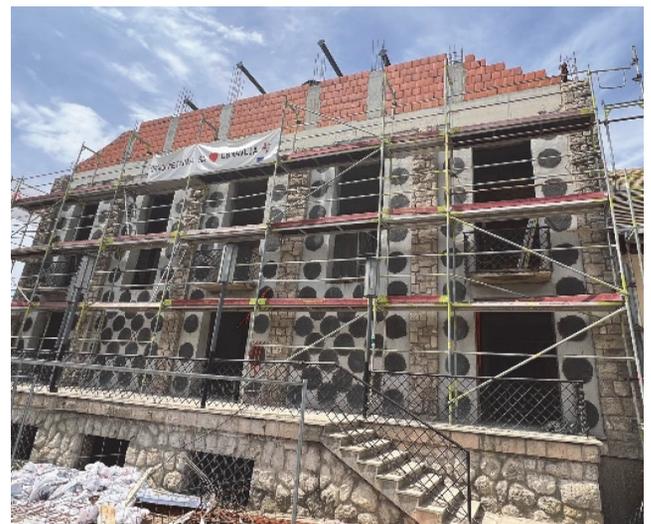
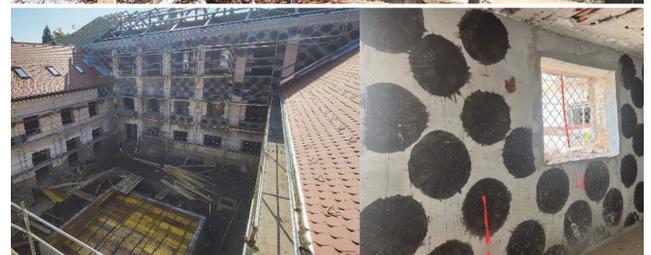
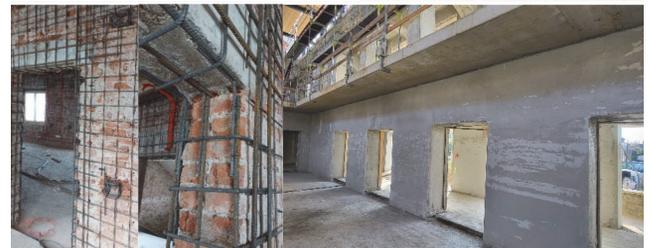
Figure 42. Execution of works on the reinforcement of the existing masonry [3]

The possibility of leveling out small vertical deflections caused by the walls' loss of stability out of plane, which turned out to be the biggest initial weakness in the building's structure, makes the use of reinforcing existing masonry walls using the reinforced plaster method appropriate in this instance.

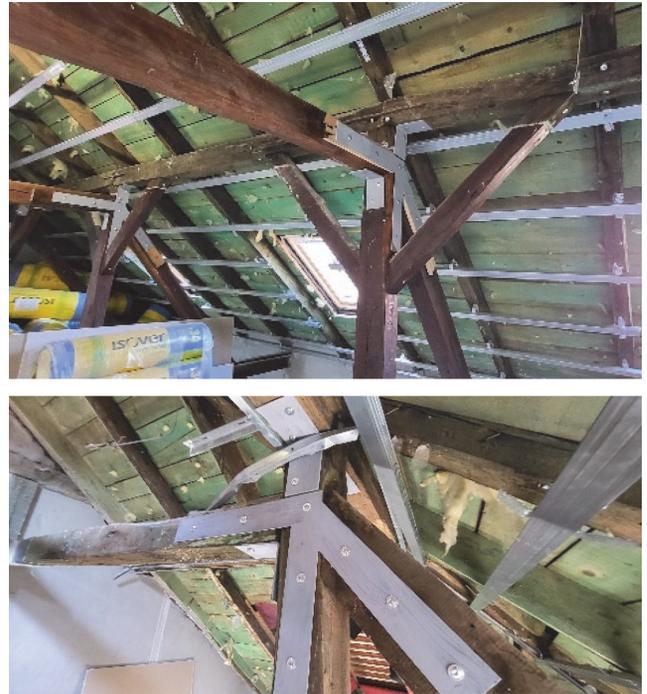
Figure 45. Execution of works on the reinforcement of the existing wooden roof structure [3]

the existing structure with additional measures to connect the nodes with the corresponding metal connections, as shown in Figure 38.
