Lessons from Grenfell Tower accident

A. Munjiza, M. Batinić, A. Mihanović

The Grenfell Tower, a building in which public flats in West London, had been hit by a fire on June 14, 2017, in which 71 people were killed and more than 70 were injured, the fire was extinguished only after 60 hours of intense shutdown

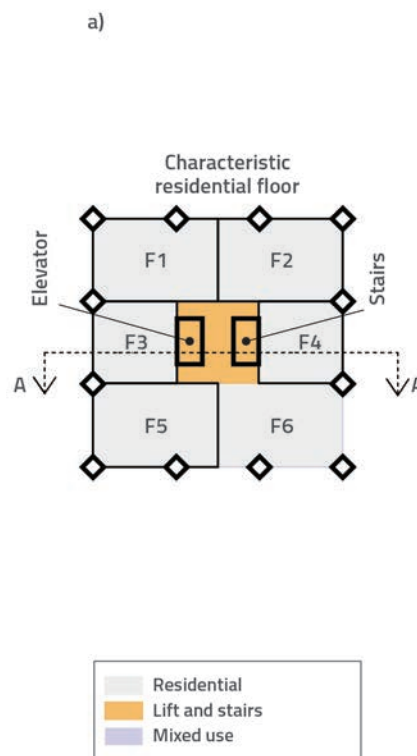
Grenfell Tower is a 24-storey (67.3 m) housing project located in North Kensington, London, UK. It was designed by Clifford Wearden and Associates in 1967, and erected by 1974. The building consists of 120 flats located on 20 residential floors, six flats per floor. The main structural system consists of RC slabs, transferring loads to inner RC core and outer RC columns, Figure 1.

Figure 1. a) Residential floor layout; b) vertical cross section showing lifts and stairs
