Comprehensive Reconstruction of the *Hrvatski dom* Building in Petrinja

Professional paper

After the 2020 earthquake, the building of the Croatian Home in Petrinja was damaged, and a comprehensive reconstruction was carried out. This paper presents the entire restoration process - from the initial inspection and investigation works, through design development and selection of the strengthening concept, to the implementation of works within the framework of the structural strengthening supervision. The reconstruction of the Croatian Home building represents an example of a successfully completed comprehensive restoration and contributes to the revitalization of life in Petrinja, as the building holds particular importance for the city's cultural life.

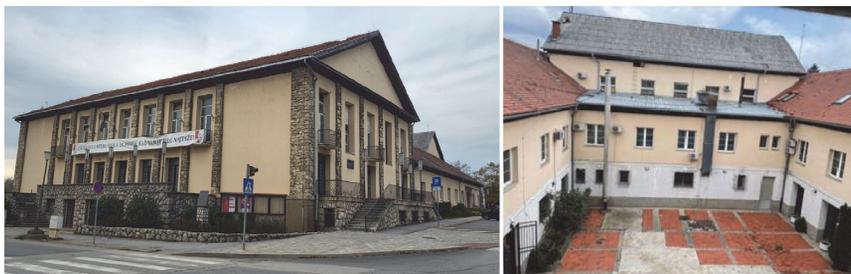
Figure 1. Southern and northern facades (towards the atrium [3])

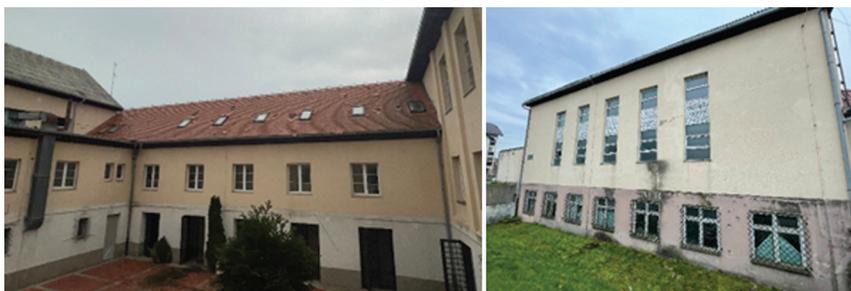
Figure 2. Eastern and western facades [3]

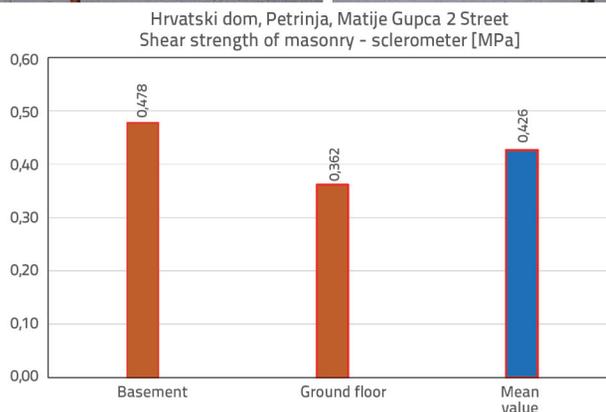
structures to establish their composition, and in-situ shear strength testing of masonry at designated positions throughout the building.

Figure 14. Examples of shear strength testing of masonry walls [7]

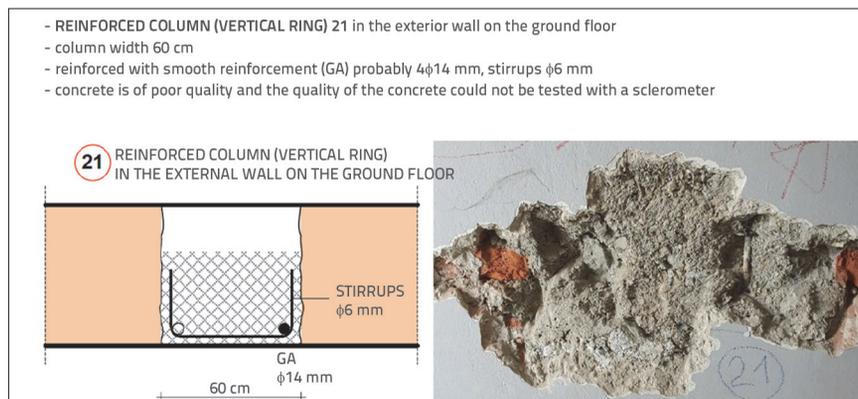
Figure 15. Examples of conducting investigation works on load-bearing elements of concrete elements within masonry walls [7]

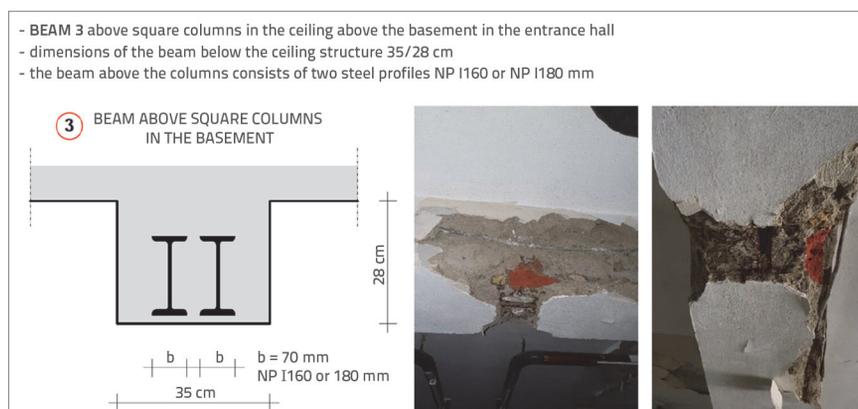
Figure 16. Examples of conducting investigation works on load-bearing elements of steel beams concealed by cladding [7]

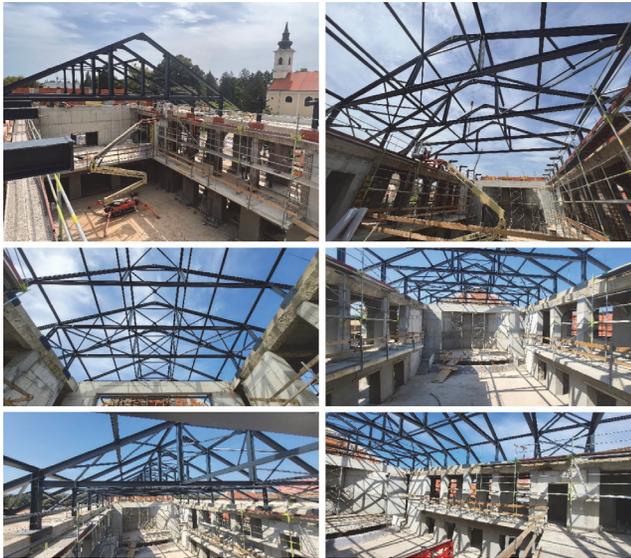
Figure 43. Execution of works on the new steel roof structure of the hall [3]

In this particular instance, it was both necessary and justified to remove the severely damaged portions of the structure (the large hall's roof) in order to replace them with reinforcements that would guarantee the earthquake resistance of the exact portion of the structure that had the initial flaws.

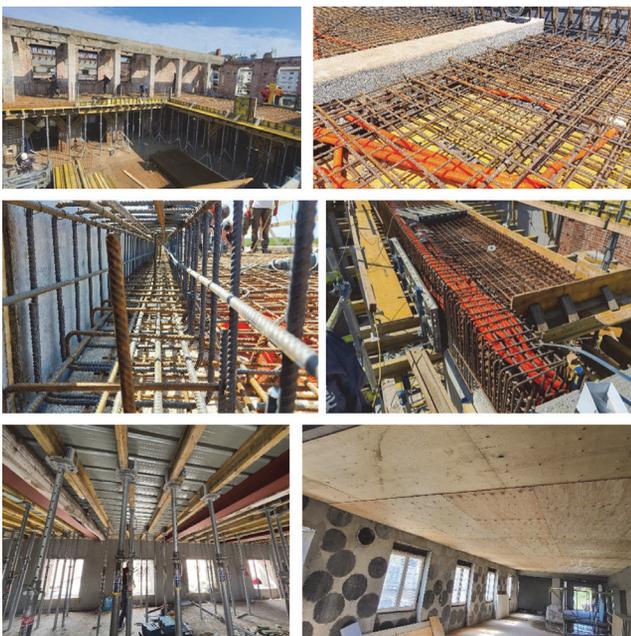
Figure 44 shows the execution of works on the new floor structures and the reinforcement of the existing floor structures. Given that no renovation of the wooden roof structure is planned in the annex zone and above the library, Figure 45 shows additional measures for connecting joints using appropriate metal connectors.

Figure 44. Execution of works on new and reinforcement of existing ceiling structures [3]

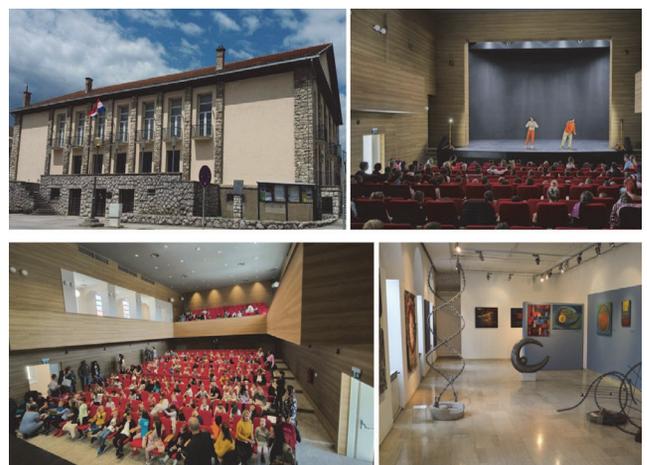
In September 2024, the newly renovated building of the "Hrvatski dom" Open University in Petrinja was officially opened. Today, the building of "Hrvatski dom" Open University accommodates the following units: "Krsto Hegedušić" Gallery, Counseling Center for Children, Adolescents and Families, Speech Therapy Office, Folklore Ensemble "Petrinjšćica", Petrinja Wind Quartet as well as Literary and Recitation Section. The structure is significant to Petrinja's cultural life.

Figure 46. Renovated building and cultural content [13]
